**LIMITED ROOF AND INTERIOR ASBESTOS SURVEY  
REGARDING  
BUILDING 1816  
SHAW AIR FORCE BASE, SOUTH CAROLINA**

**Date of Inspection: March 20, 2024  
Date of Report: April 5, 2024**

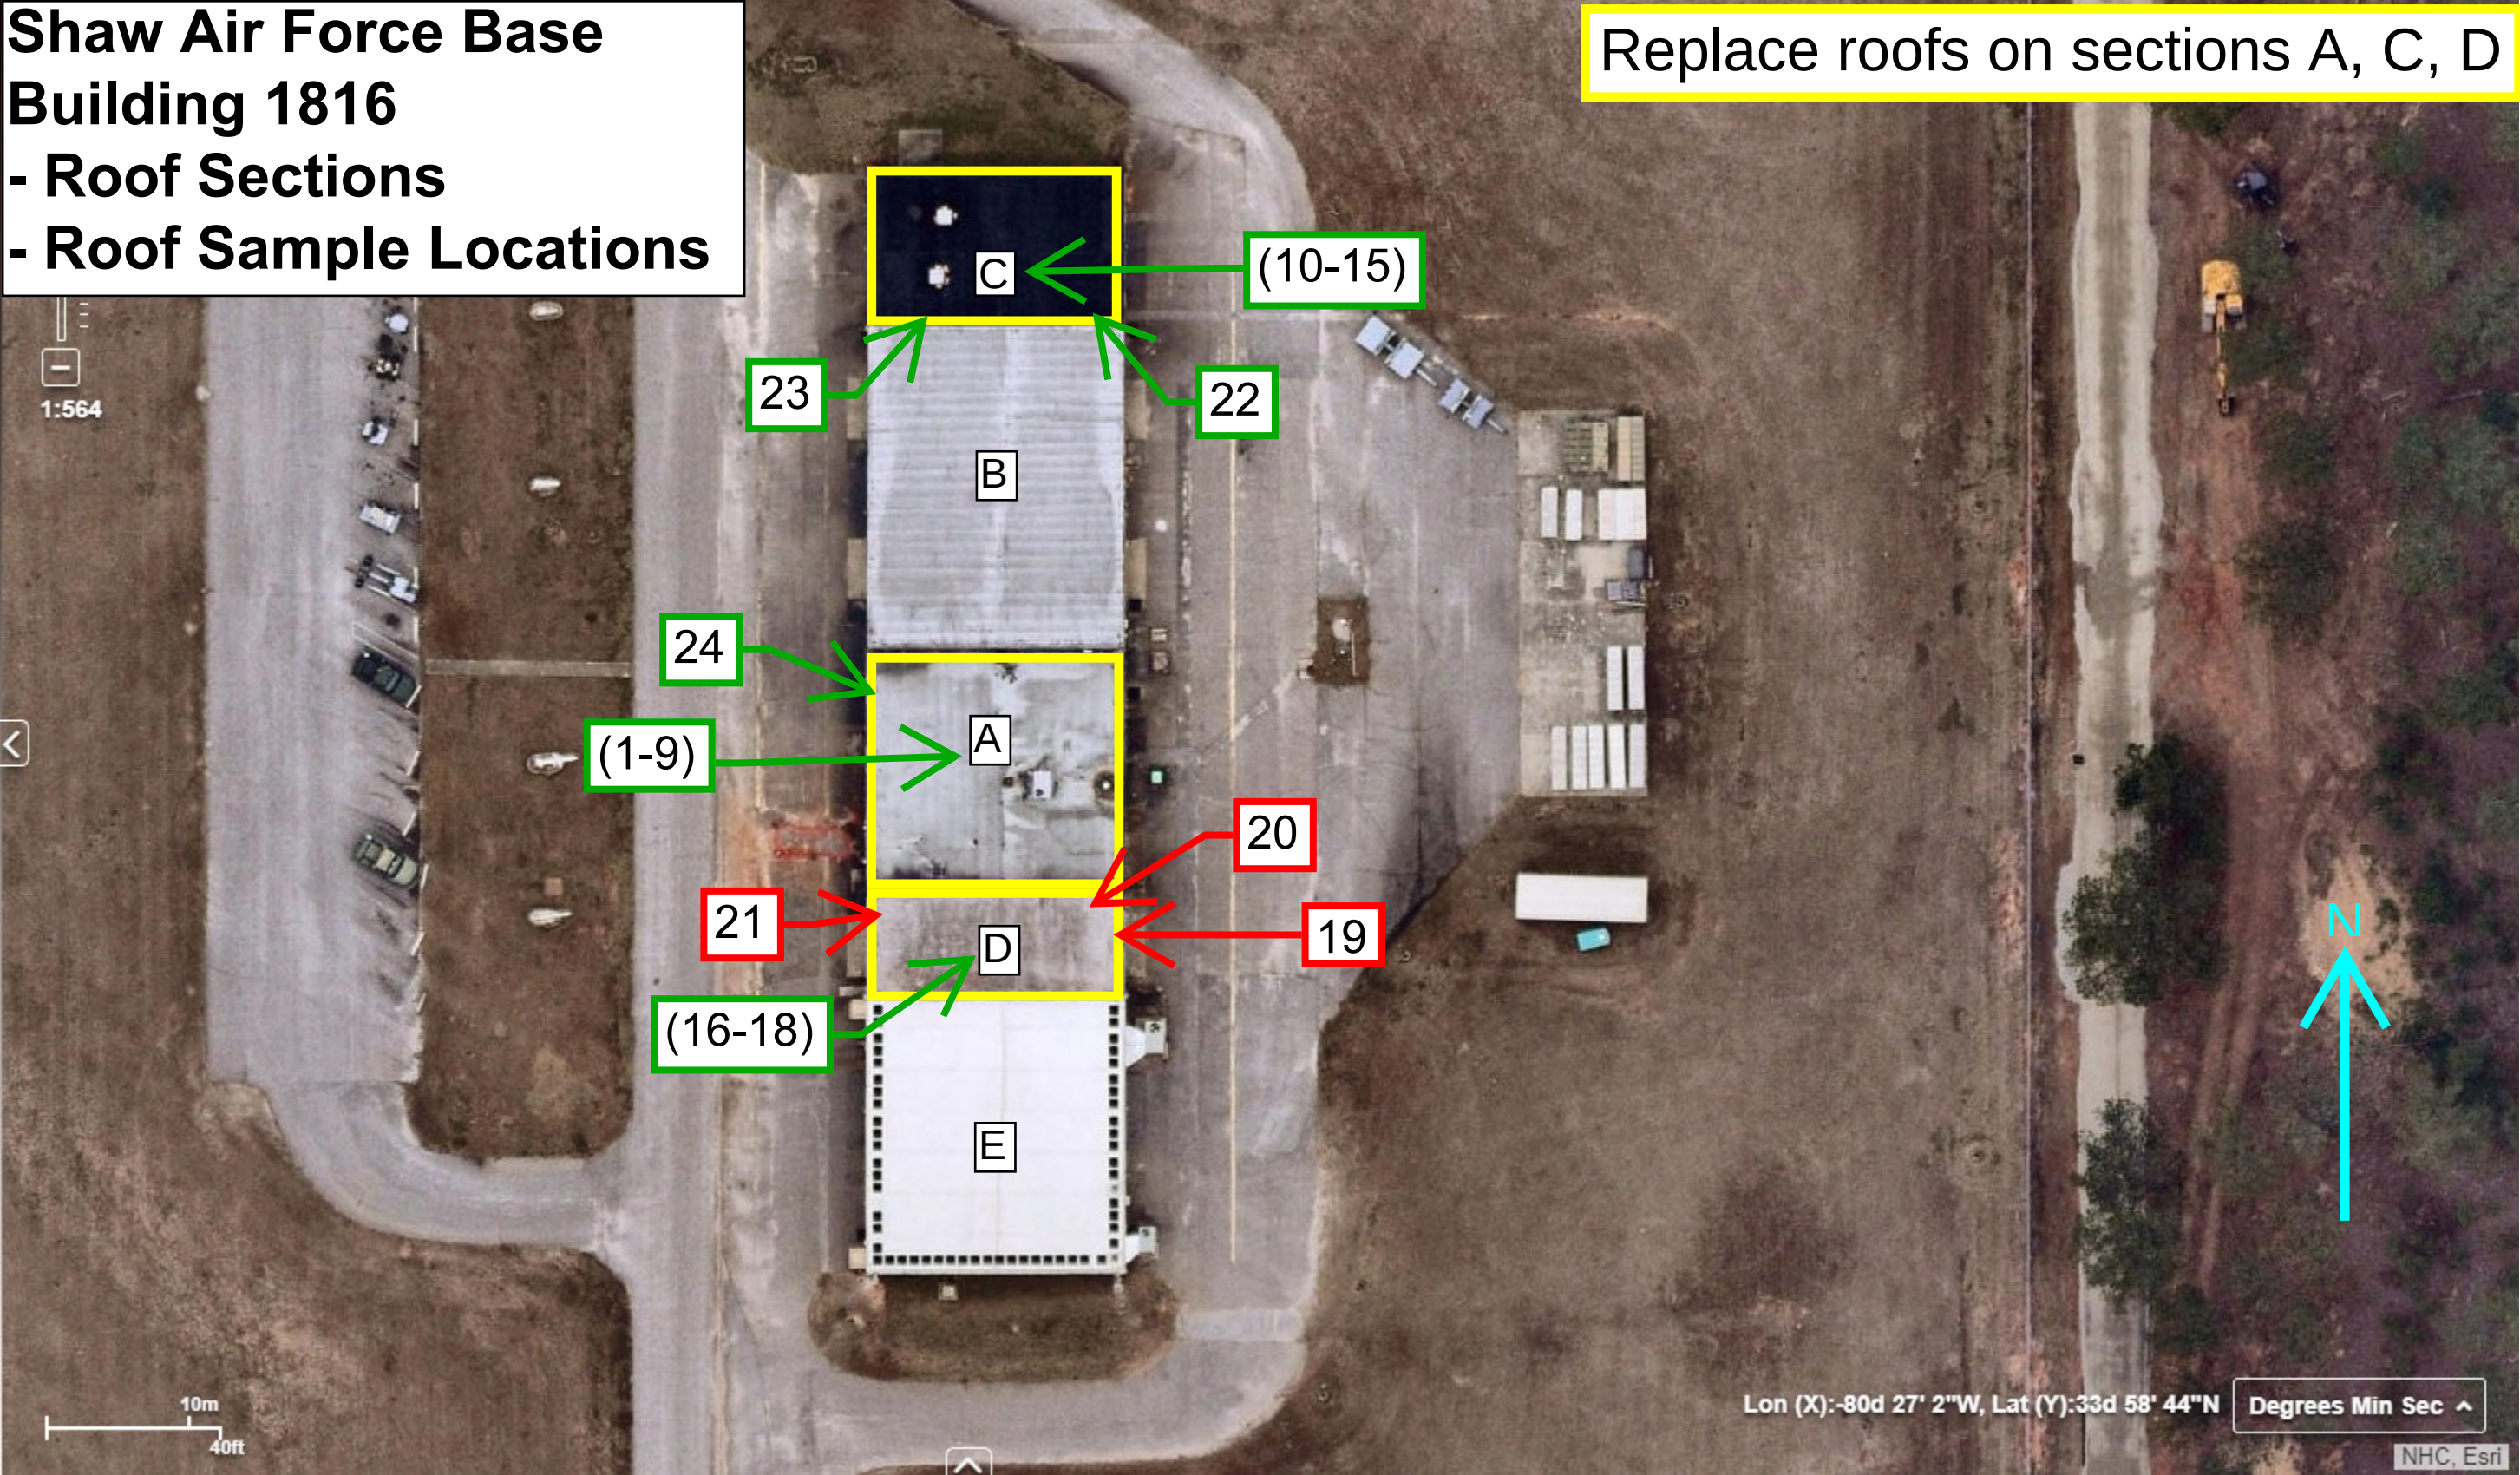
# Shaw Air Force Base Building 1816

Replace roofs on sections A, C, D

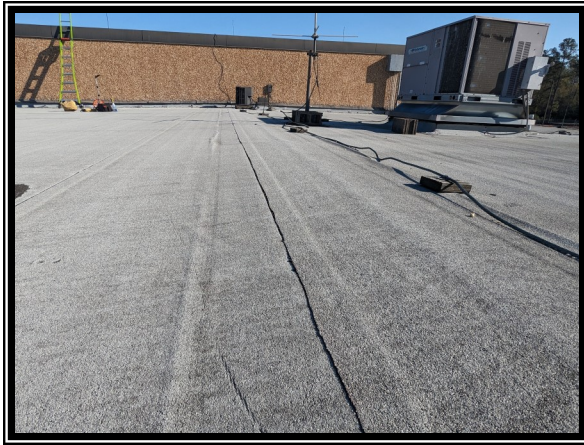
Photo #1  
No Asbestos Detected in Roofing Layers of  
Roof Section A

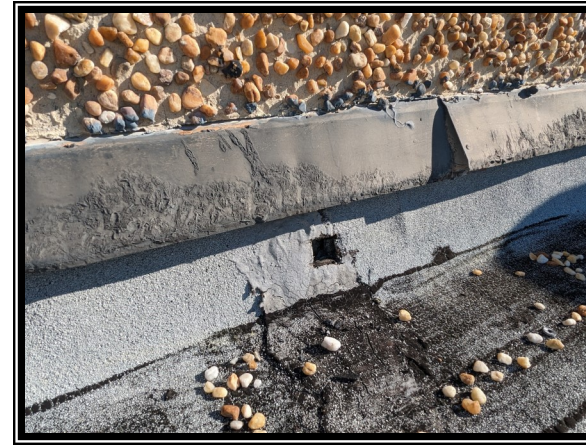
Photo #2  
No Asbestos Detected in Base Layers or Metal  
Flashing Materials of Roof Section A

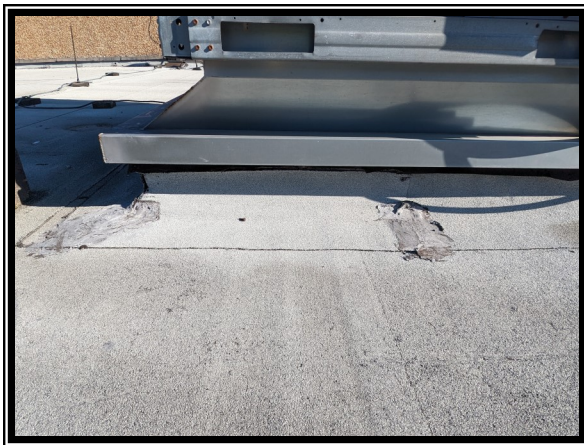
Photo #3  
View Depicting Curb Sealants of Roof Section A

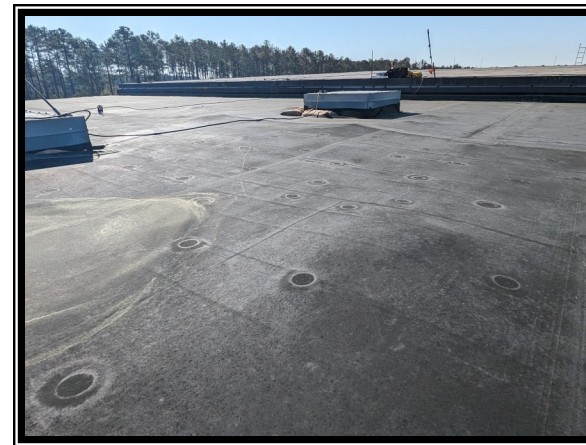
Photo #4  
No Asbestos Detected in EPDM Roof System of  
Roof Section C.

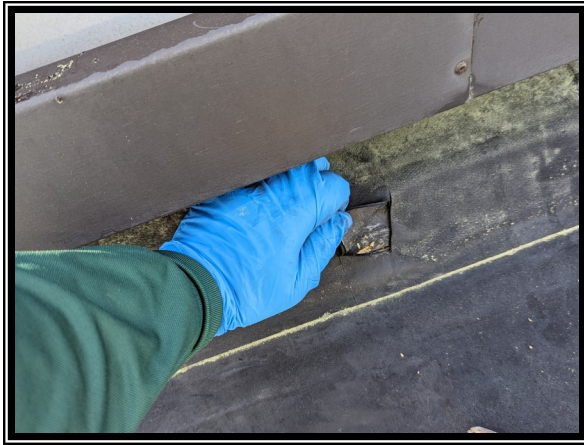
Photo #5  
No Asbestos Detected in Wall/Curb Base  
Sealant Layers of Roof Section C

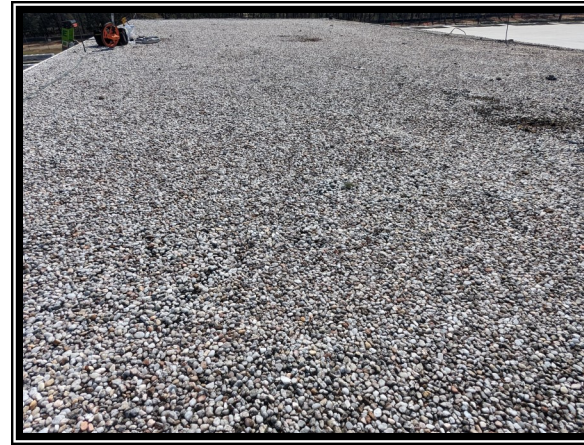
Photo #6  
No Asbestos Detected in Built-up Roofing  
Layers of Roof Section D

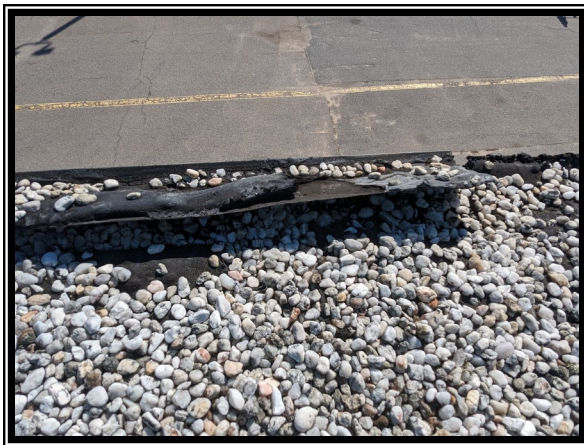
Measuring approximately 60' x 25', the flat metal deck has layers of stone-covered, built-up roofing layers. Metal flashing around the perimeter edge of the roof is sealed with a tar-like, asbestos-containing sealant.

| Description | Location | Category (F/NF) | Approx. SF/LF |
|---|---|---|---|
| Black Sealant Associated with Metal Roof-edge Flashing | Perimeter of Roof Section D | Cat. I – NF – Good Condition | 170 LF |

Photo #7  
**Asbestos Detected at 5% in Sealant Layers  
of Perimeter Flashing on Roof Section D**

Based upon the inspection of March 20, 2024, and the analytical results from the samples collected and tested by an independent laboratory, the metal roof-edge flashing of Roof Section D, located at Building 1816 of Shaw Air Force Base, S.C., does contain non-friable ACM, as per Table 1. Such materials will have to be removed and properly disposed by a S.C. licensed abatement contractor per SC DHEC Bureau of Air Quality Asbestos Regulation 61-86.1 effective May 27, 2011, prior to renovation activities involving the asbestos-containing materials.

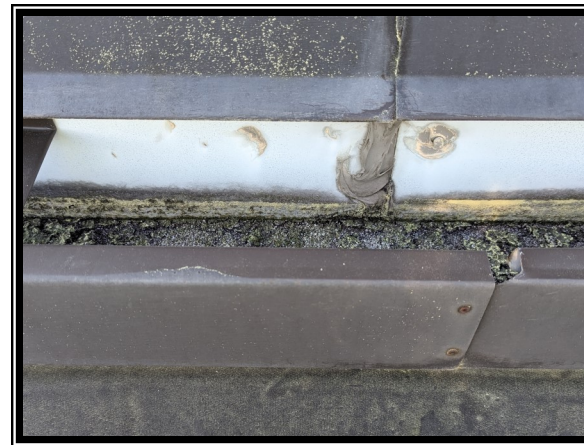
Photo #8  
No Asbestos Detected in Roof Gutter Caulking

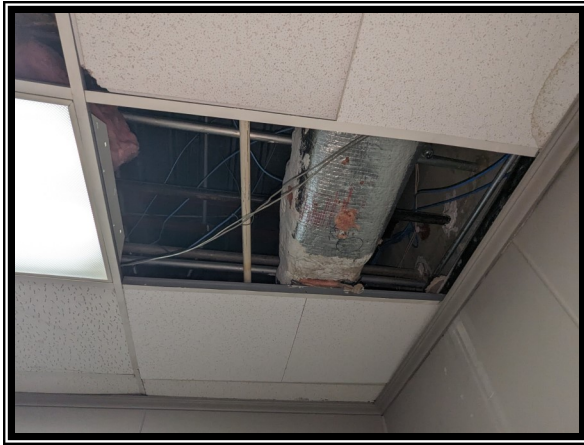
Photo #9  
No Asbestos Detected in Ceiling Tiles or HVAC  
Duct Materials in the Office Areas

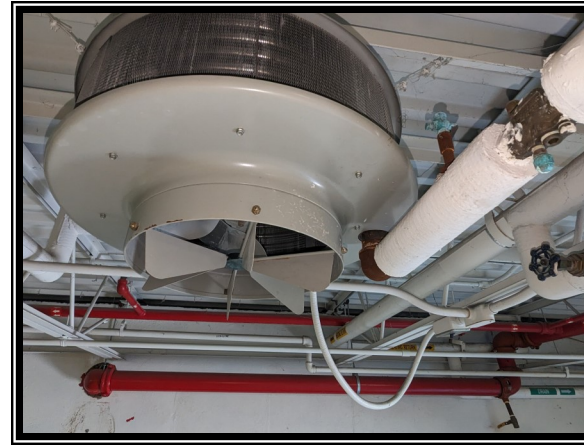
Photo #10  
No Asbestos Detected in Ceiling-mounted Fan  
Coils' Pipe Wrap Material

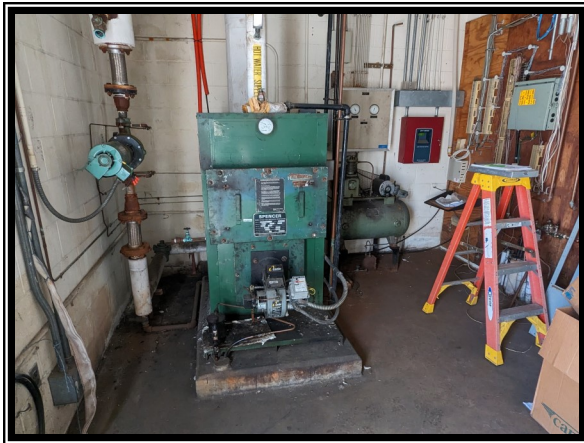
Photo #11  
View Depicting Boiler Equipment in Boiler Room

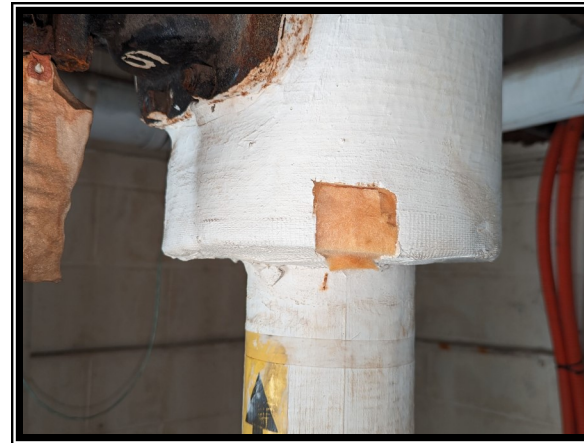
Photo #12  
No Asbestos Detected in Boiler Pipe Wrap or  
Mastic Materials
